Reference: Johnson Street Bridge: Steel Repairs

Stantec completed an inspection of the underside of the main span of the Johnson Street Bridge on Tuesday March 29, 2011. The inspection was done using the gantries below the road bridge and the rail bridge.

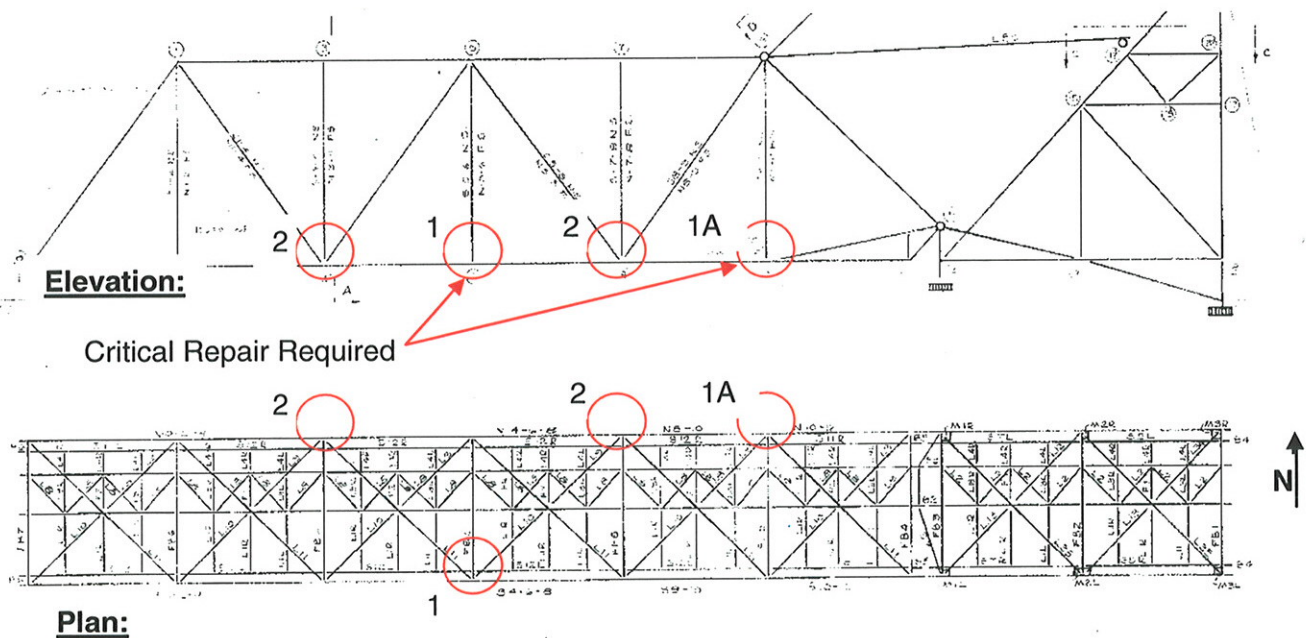
During the inspection we found two locations on the rail bridge where we recommend scheduling immediate repairs. These locations are shown in further detail in Figure 1 below.

Figure 1: Rail Bridge Steel Repairs

The critical areas are the panel points where the deck is hung from the vertical truss member and there are no diagonal members to share the load.

Less serious deteriorated areas occur on the verticals that go up to the top truss from the lower panel points, shown as detail 2 on Figure 1. These locations require all 4 angles to be repaired, but perhaps could be stayed if rail traffic is not to be reinstated on the bridge.

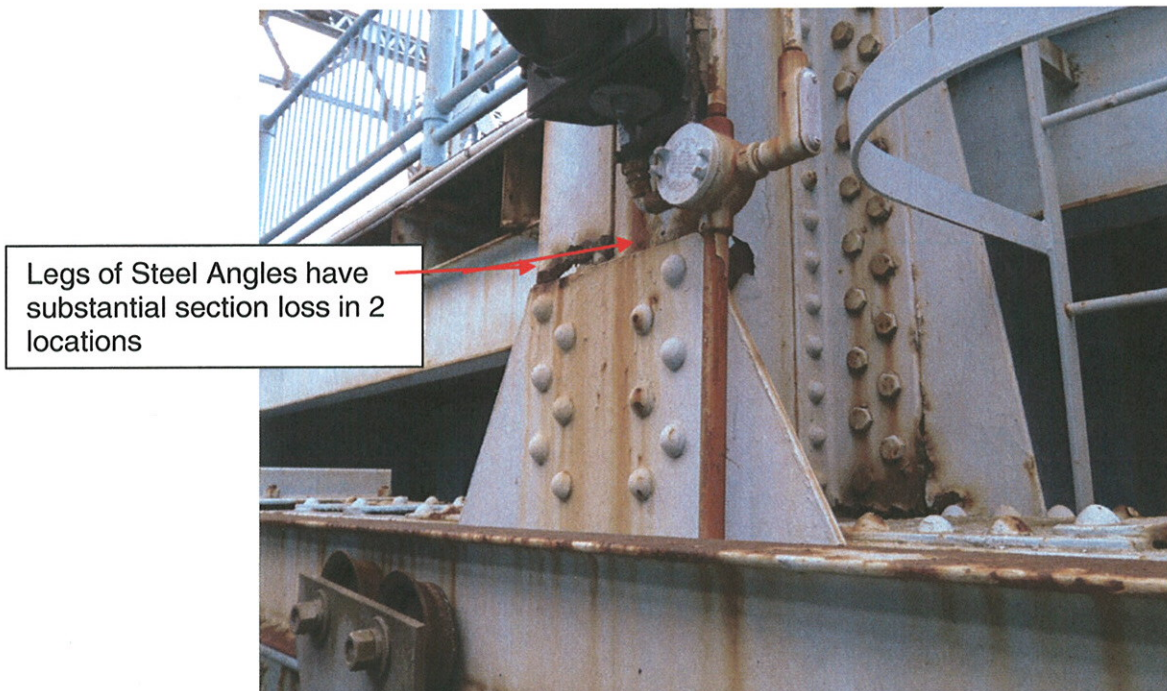
Critical repair detail 1 requires at least 2 repairs and can be seen in further detail in Figure 2 below.

Figure 2: Photo of Critical repair 1 at Rail Bridge

Critical repair detail 1A is similar to critical repair detail 1, except that all 4 angles need to be repaired. The repairs will all be similar to the repair sketch that Andrew Rushforth provided for member 15-16 on the South counterweight frame, with the welds extending at least 12" each way past the deteriorated area. A detail of the required repairs is shown in Figure 3 below.

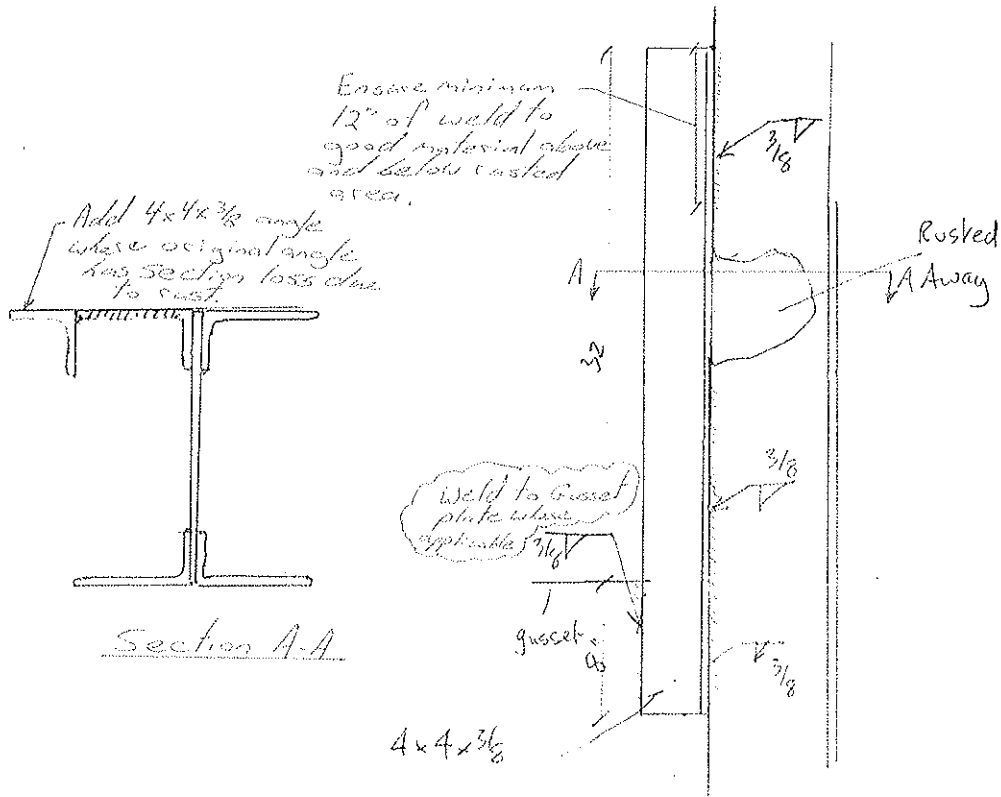
Figure 3: Typical Repair Sketch

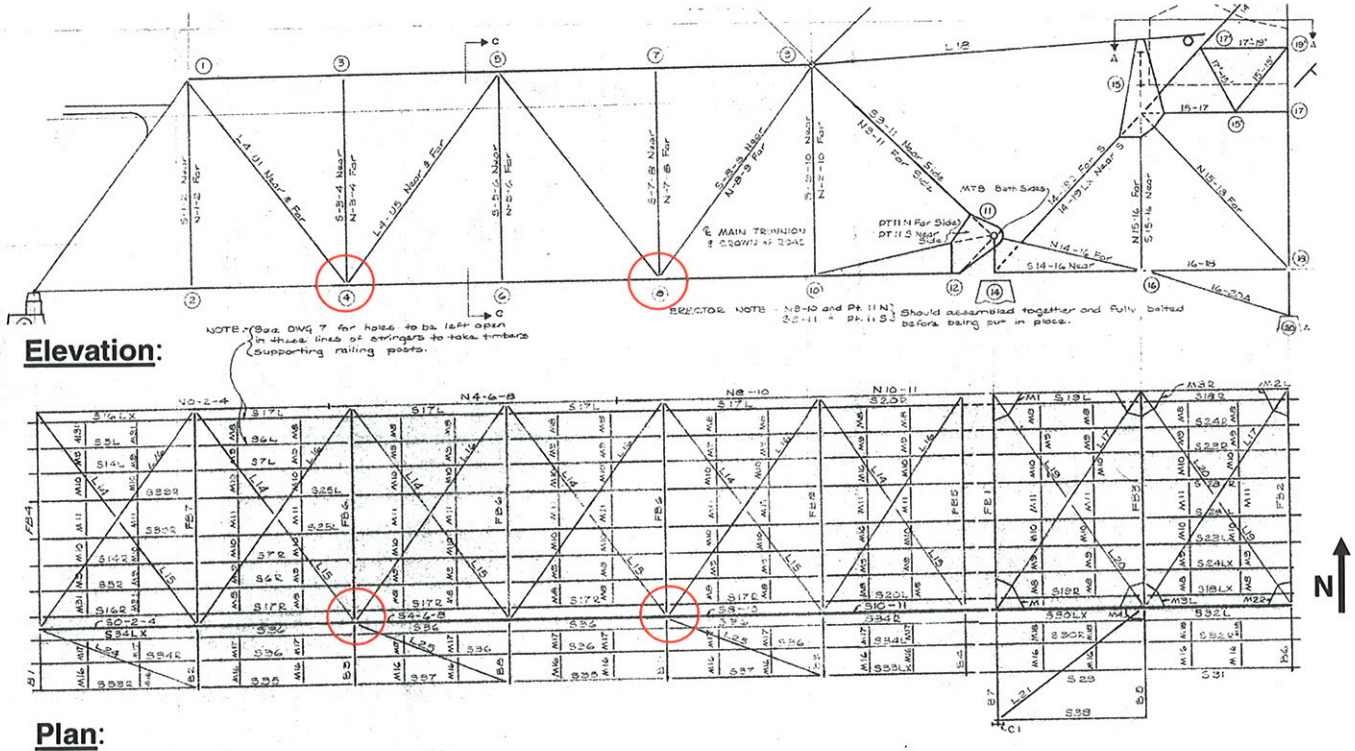
During the inspection of the road bridge we also found two areas that should be repaired. These repairs were not identified as critical, but should be coordinated with the other more urgent repairs. The locations of these repairs can be seen in Figure 4. There are also bearing stiffeners under the fixed spans that should be replaced at the same time as these repairs are being done. We estimate that there are 3-4 bearing stiffeners that will require repairs at this time. Stantec will coordinate the exact locations and repair details while this work is taking place.

Figure 4: Road Bridge Steel Repairs

Both locations require repair to the two South facing angles. Further detail of the area to be repaired can be seen in Figure 5.

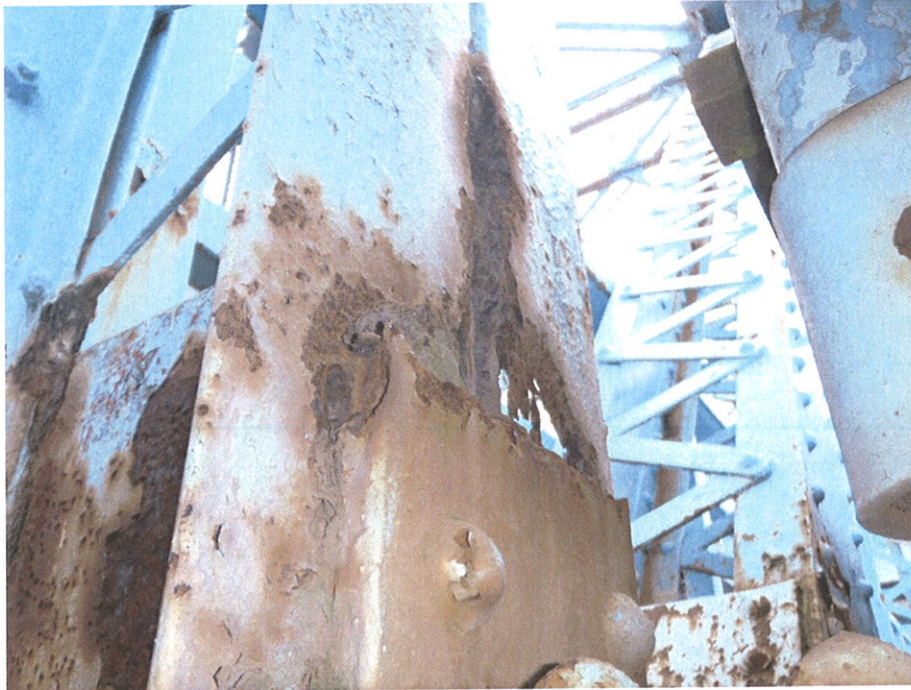
Figure 5: Photo of Recommended Repair Location at Road Bridge

This photo was taken at the furthest west location, but is typical of both areas that require repairs. Repairs should be completed as per Figure 3 above.
