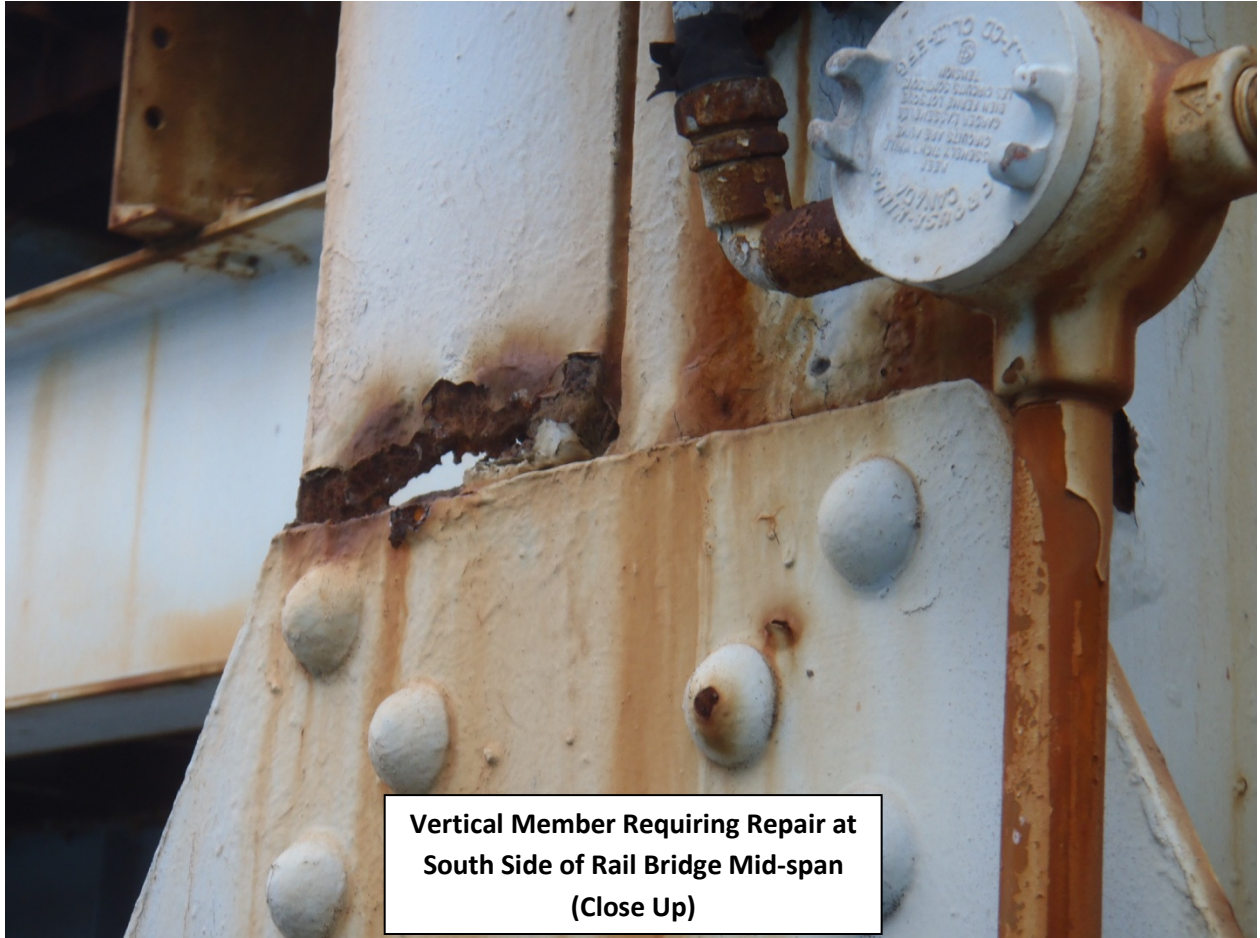
**Vertical Member Requiring Repair at  
South Side of Rail Bridge Mid-span  
(Close Up)**
