Governance and Priorities Committee Report

Date: April 6, 2011 **From:** Mike Lai, Johnson Street Bridge Project Director
Subject: Johnson Street Bridge Structural Inspections

Reference: Johnson Street Bridge: Steel Repairs

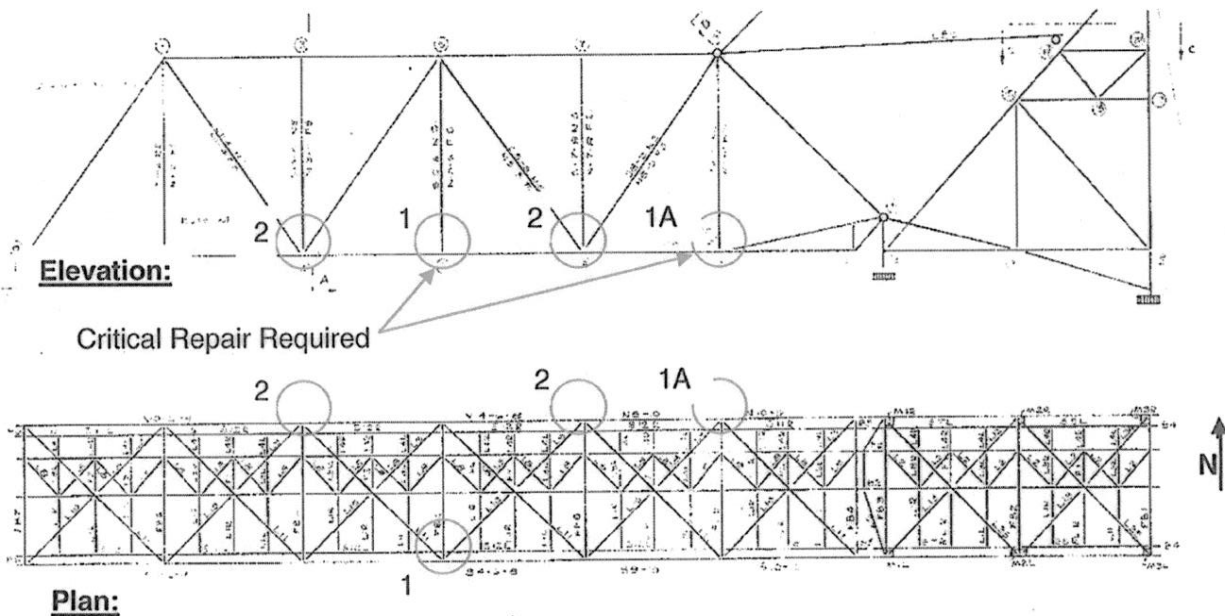
Figure 1: Rail Bridge Steel Repairs

During the inspection we found two locations on the rail bridge where we recommend scheduling immediate repairs. These locations are shown in further detail in Figure 1 below.

The critical areas are the panel points where the deck is hung from the vertical truss member and there are no diagonal members to share the load.

Less serious deteriorated areas occur on the verticals that go up to the top truss from the lower panel points, shown as detail 2 on Figure 1. These locations require all 4 angles to be repaired, but perhaps could be stayed if rail traffic is not to be reinstated on the bridge.

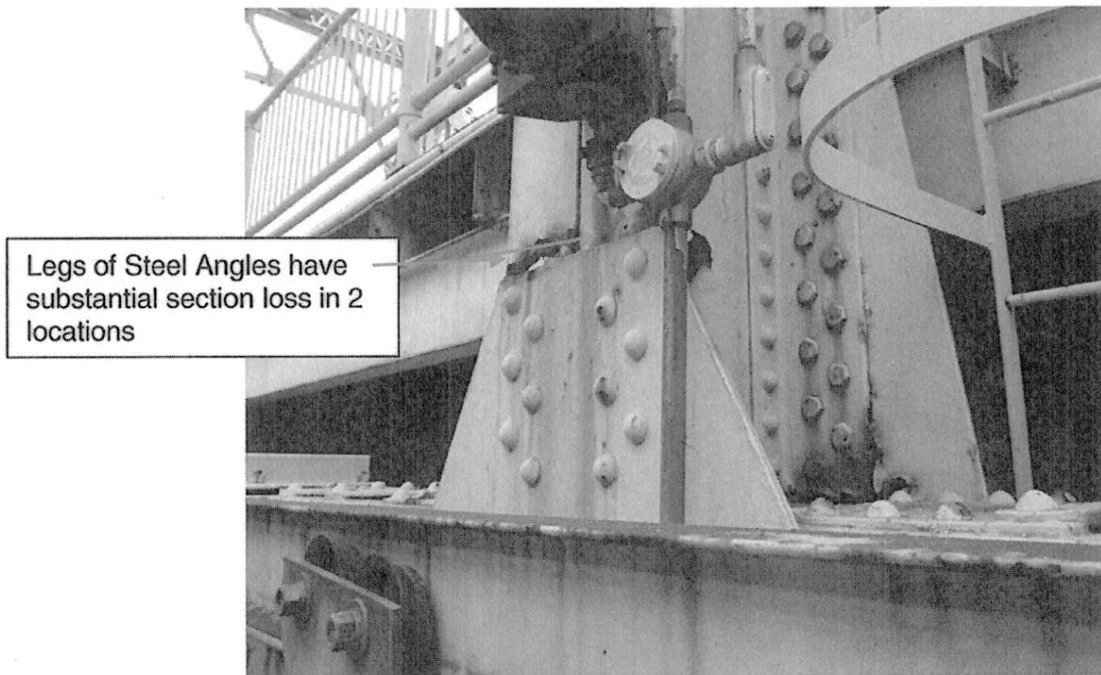
Figure 2: Photo of Critical repair 1 at Rail Bridge

Critical repair detail 1 requires at least 2 repairs and can be seen in further detail in Figure 2 below.

Critical repair detail 1A is similar to critical repair detail 1, except that all 4 angles need to be repaired. The repairs will all be similar to the repair sketch that Andrew Rushforth provided for member 15-16 on the South counterweight frame, with the welds extending at least 12" each way past the deteriorated area. A detail of the required repairs is shown in Figure 3 below.

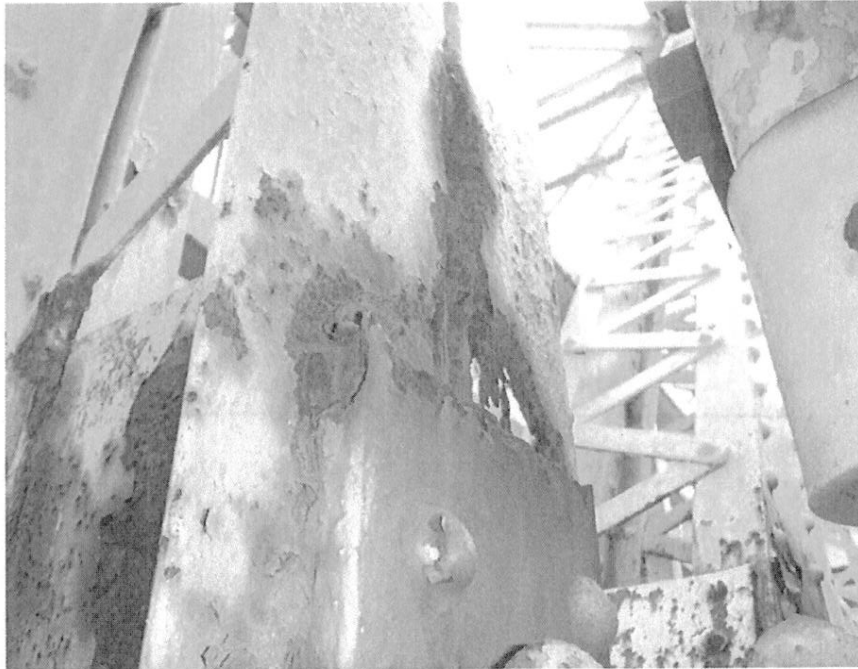
Figure 5: Photo of Recommended Repair Location at Road Bridge

During the inspection of the road bridge we also found two areas that should be repaired. These repairs were not identified as critical, but should be coordinated with the other more urgent repairs. The locations of these repairs can be seen in Figure 4. There are also bearing stiffeners under the fixed spans that should be replaced at the same time as these repairs are being done. We estimate that there are 3-4 bearing stiffeners that will require repairs at this time. Stantec will coordinate the exact locations and repair details while this work is taking place.

This photo was taken at the furthest west location, but is typical of both areas that require repairs. Repairs should be completed as per Figure 3 above.
