Hazardous Materials Survey

VIA Rail Building

Victoria, BC

NWEG Project: 17958

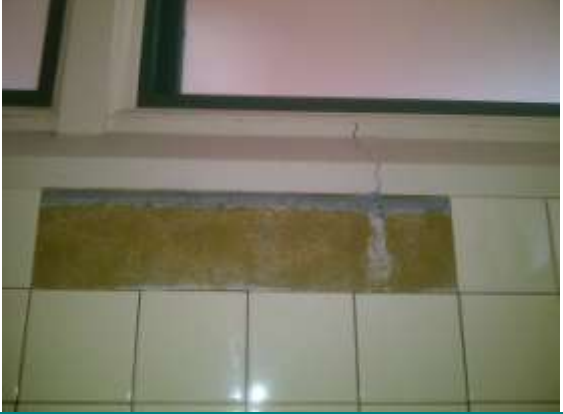
<p>Sample: 17958-01 Unit/Location: Women's Washroom Description: Mastic – Ceramic Tile Asbestos: None Detected</p>	<p>Sample: 17958-02 Unit/Location: Janitor's Closet Description: Drywall Joint Compound Asbestos: None Detected</p>
